INDOOR AIR QUALITY ASSESSMENT

**Nashoba Regional High School
12 Green Road
Bolton, Massachusetts 01701**

Prepared by:
Massachusetts Department of Public Health
Center for Environmental Health
Emergency Response/Indoor Air Quality Program
July 2006

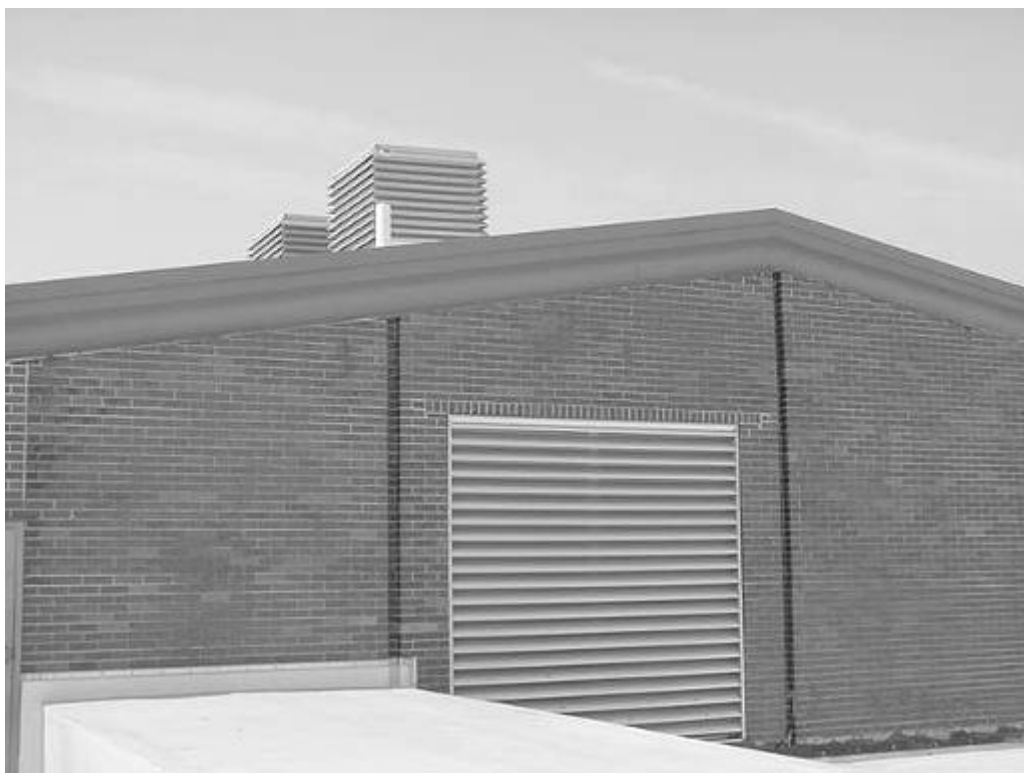
Picture 1

Exterior View of Large Passive Vent for HVAC Penthouse

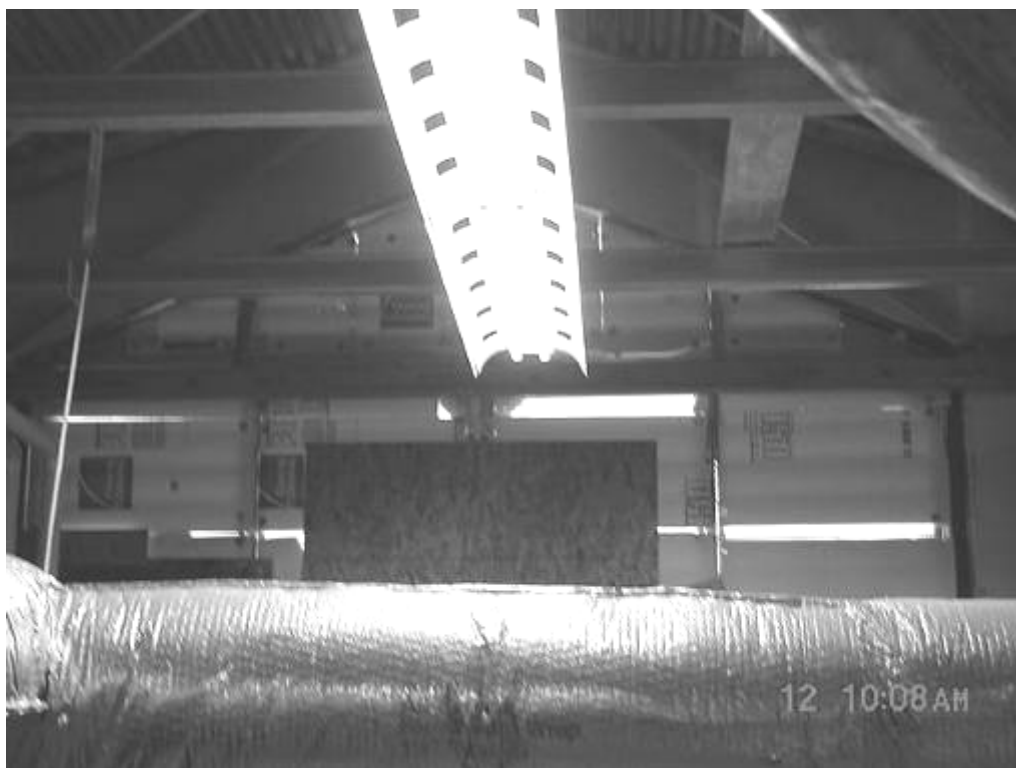
Picture 2

Interior View of Passive Vent Sealed With Insulation Material

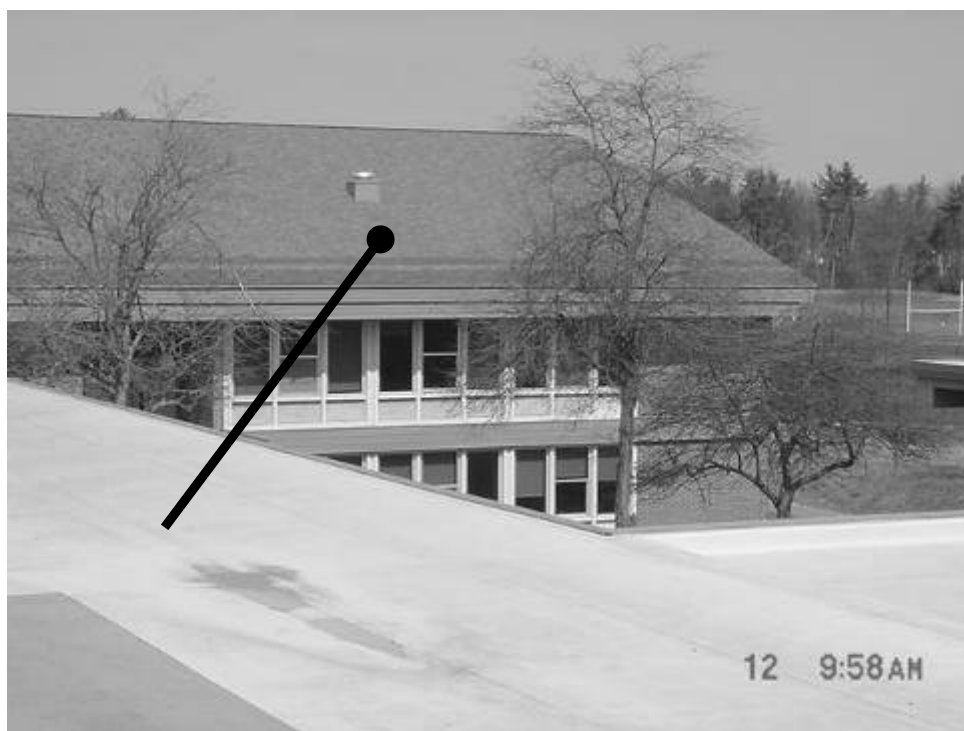
Picture 3

Mechanical ventilation is provided by air-handling units (AHUs) located in the attic (Pictures 3 and 4). Fresh air is drawn through two sets of pleated air filters (Pictures 5 and 6) and continuously distributed via ducted air diffusers located in vertical columns along the perimeter of classrooms (Picture 7). Air is ducted back to AHUs via ceiling or wall-mounted return vents (Pictures 8). Several air diffusers were obstructed by stored materials impeding airflow. Several science labs are equipped with additional local exhaust ventilation that can be activated to aid in the removal of odors/particulates during experiments.

Attic Where AHUs are Located

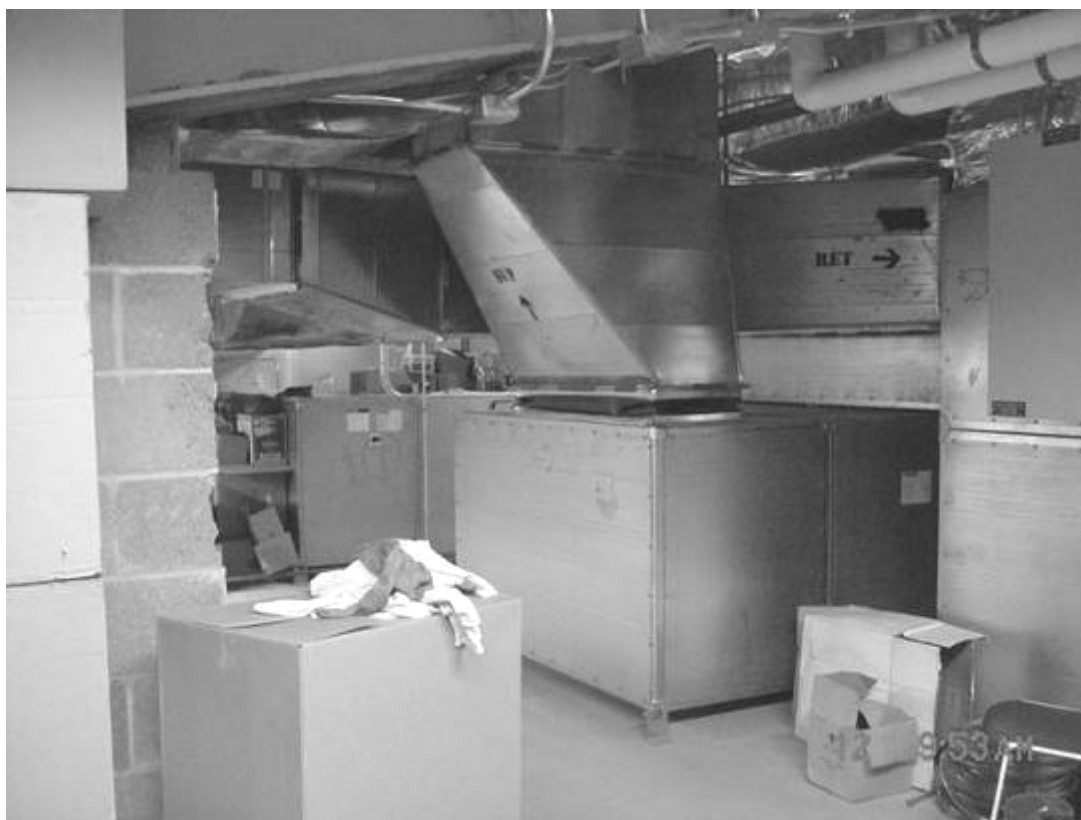
Picture 4

AHU Located in Attic

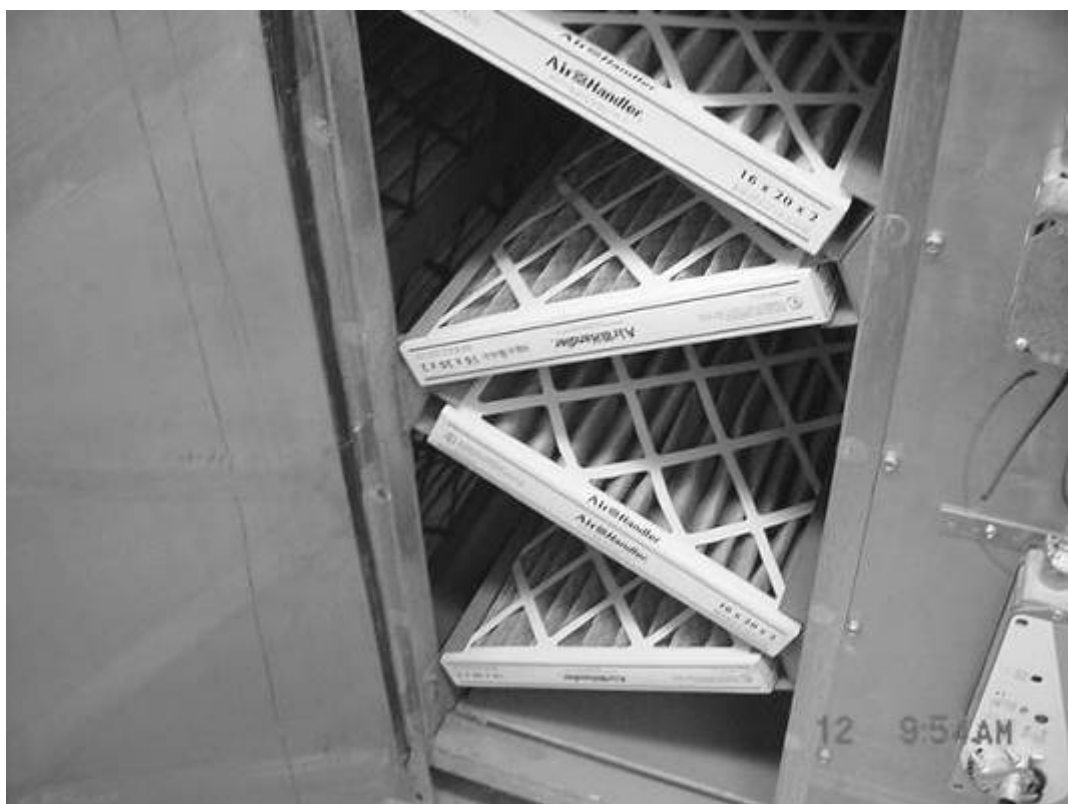
Picture 5

Bank of Pleated Air Filters in AHU

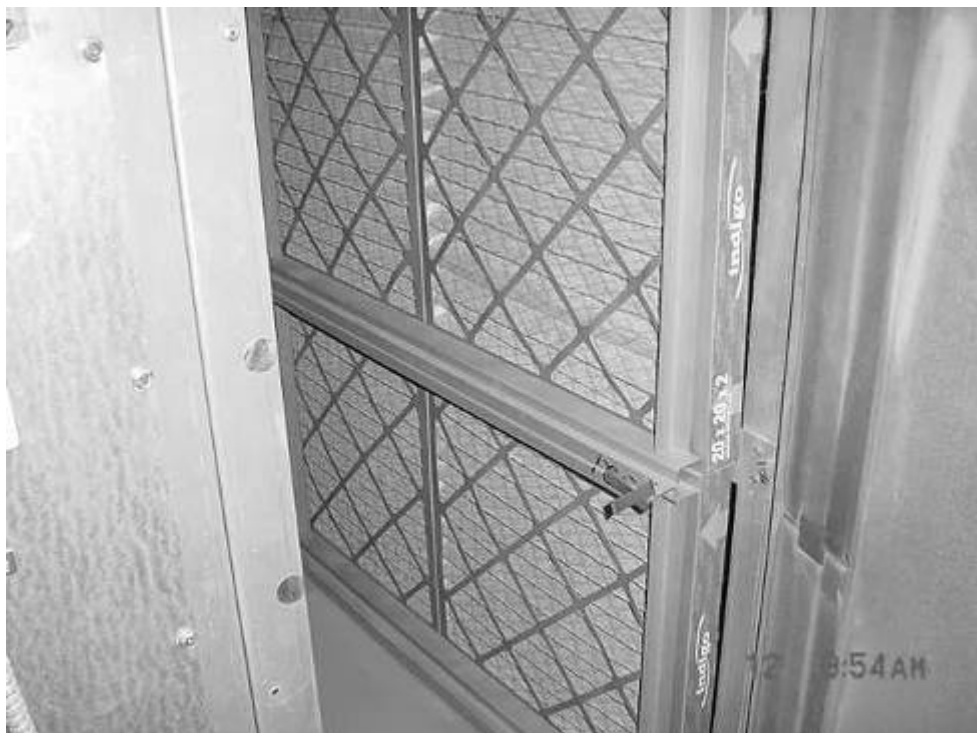
Picture 6

2nd Bank of Pleated Air Filters in AHU

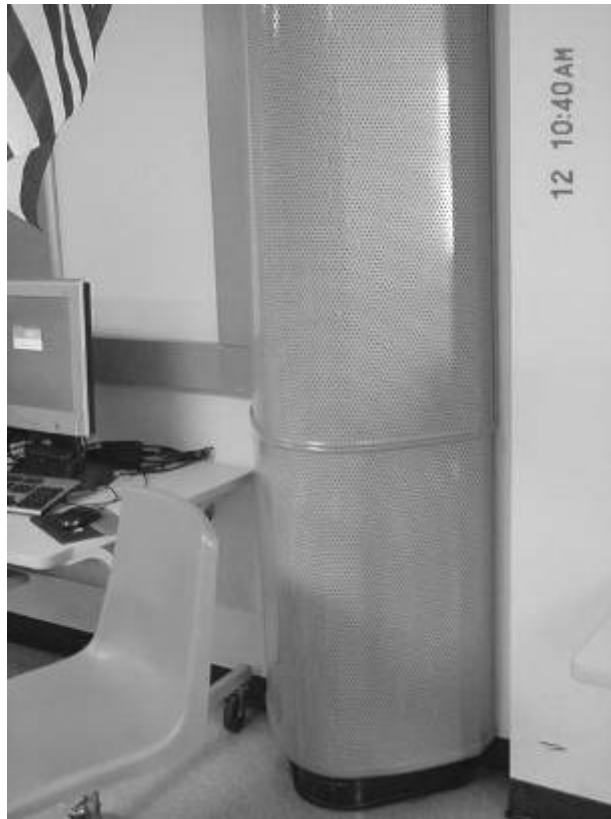
Picture 7

Column Shaped Air Diffusers

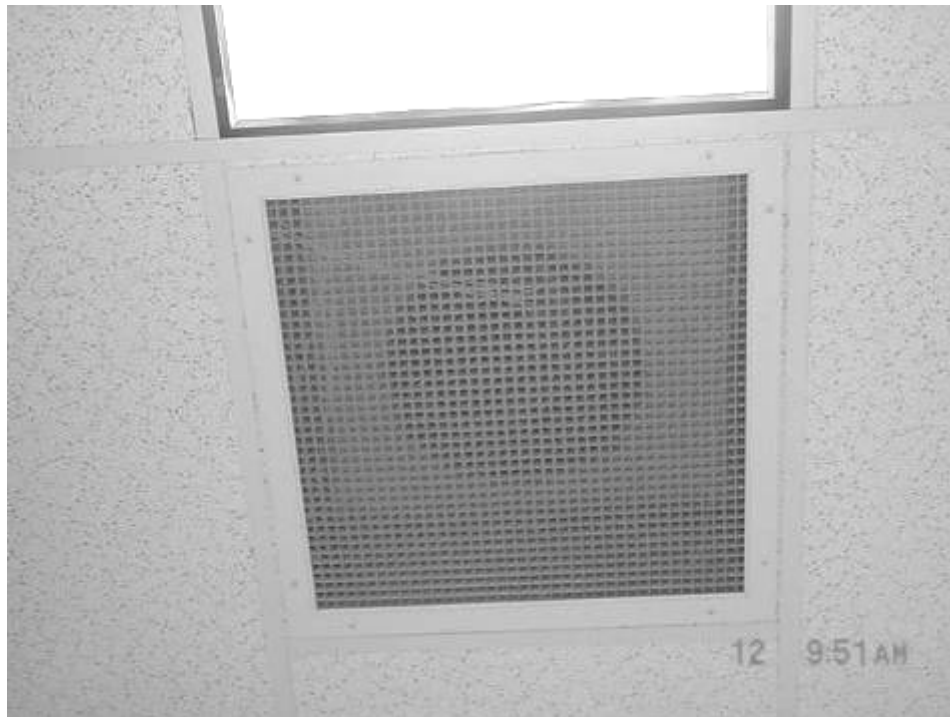
Picture 8

Ceiling-Mounted Return/Exhaust Grill

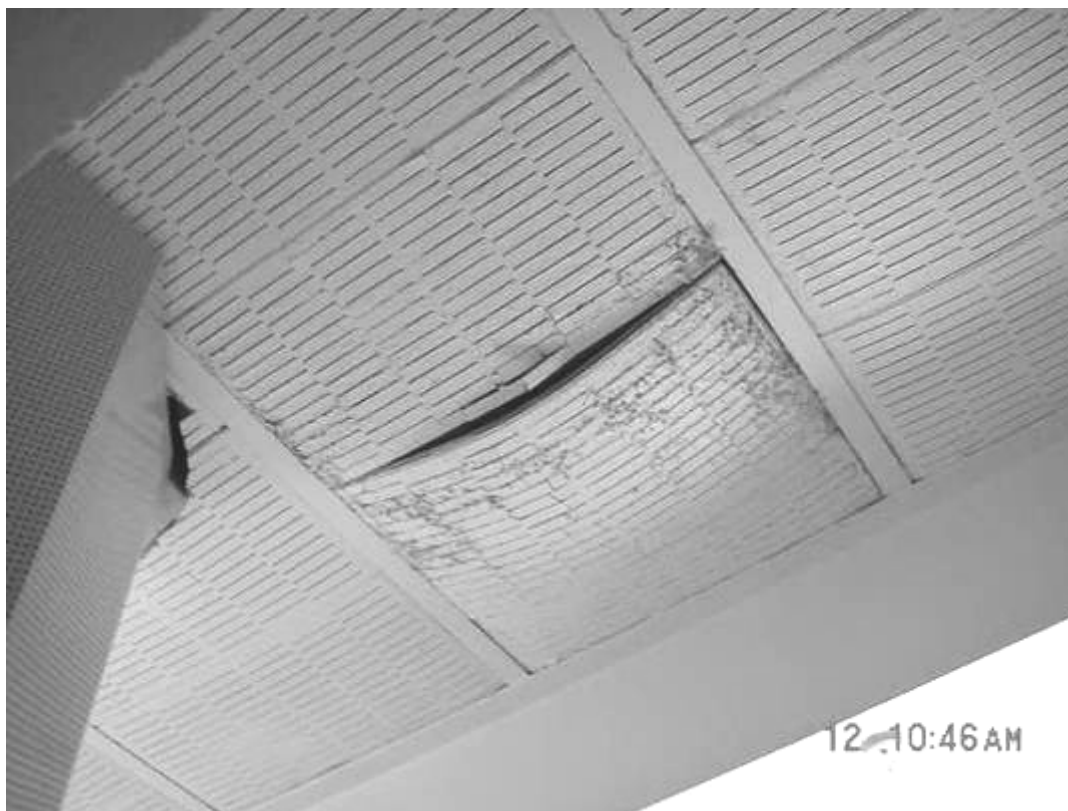
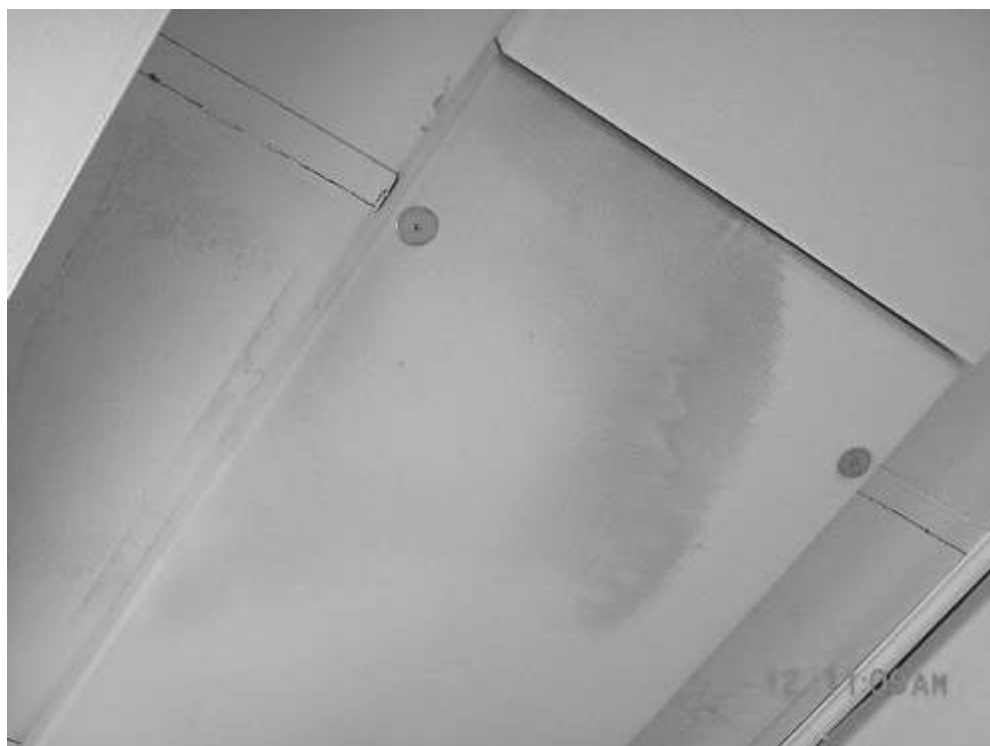
Water Damaged Ceiling Panels

6. Remove/replace water damaged ceiling panels. Examine the area above and around these areas for mold growth. Disinfect areas of water leaks with an appropriate antimicrobial.

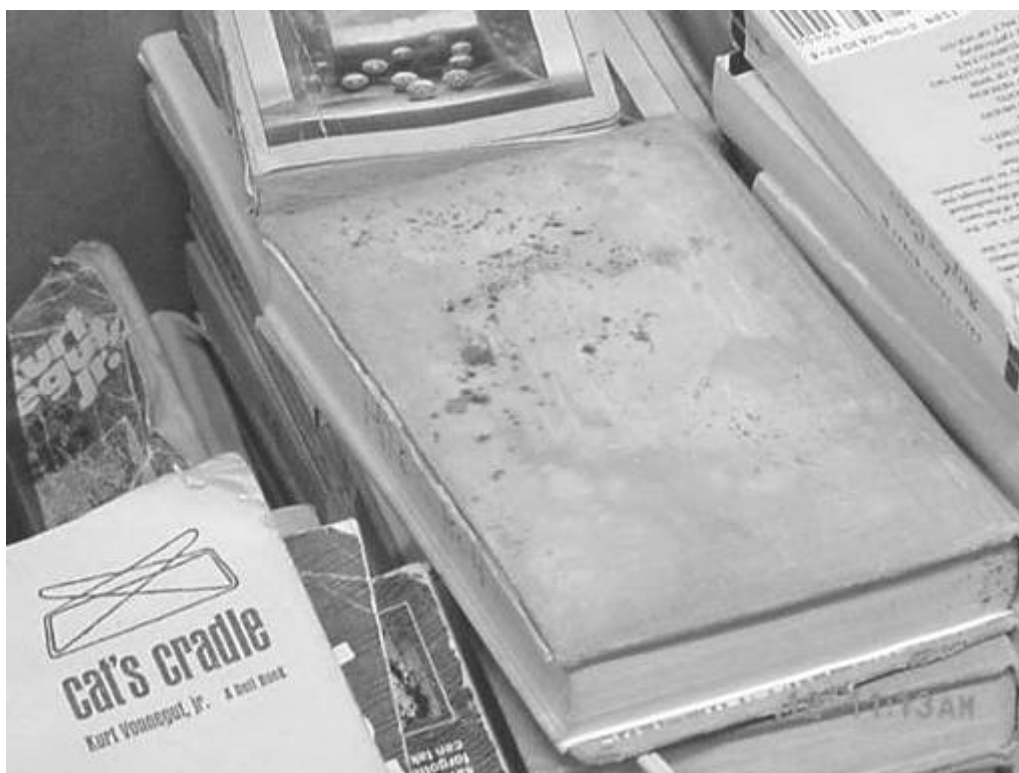
Picture 11

Several moldy books and associated odors were also observed in storeroom 206-A (Picture 11), which is an interior room with no ventilation. CEH staff recommended discarding the moldy items.

Mold Colonized Books in Storeroom 206A

7. Inspect and discard mold-contaminated books, boxes and other porous items in storeroom 206-A.
8. Clean/maintain aquariums/terrariums to prevent mold/bacterial growth and associated odors.

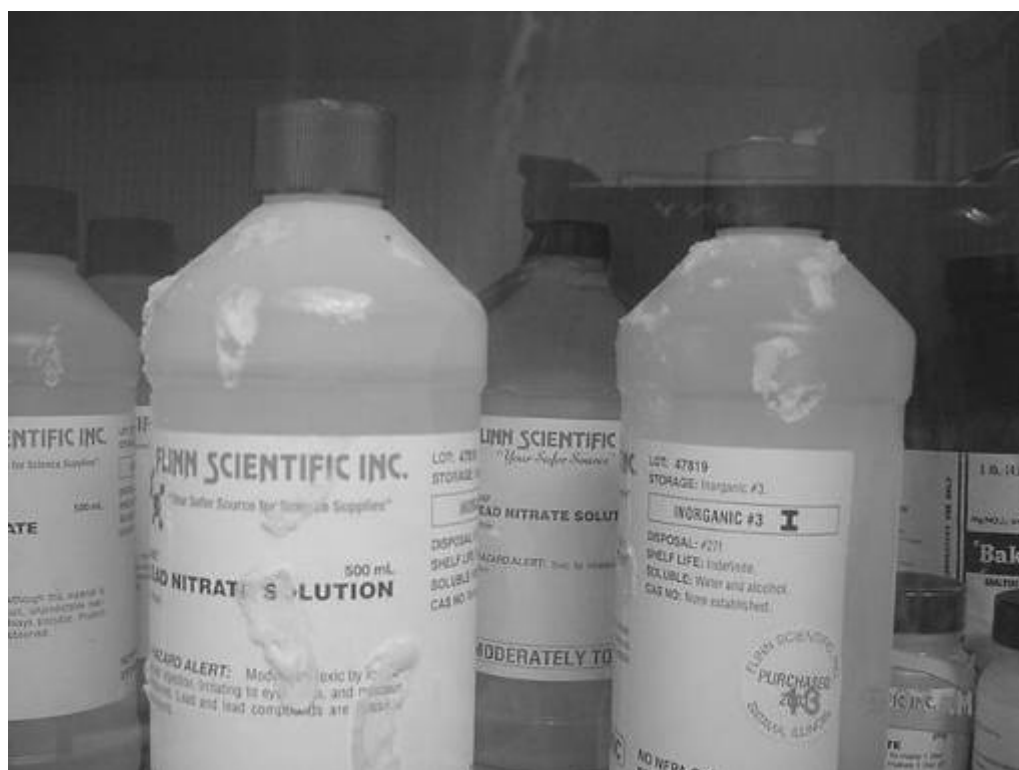
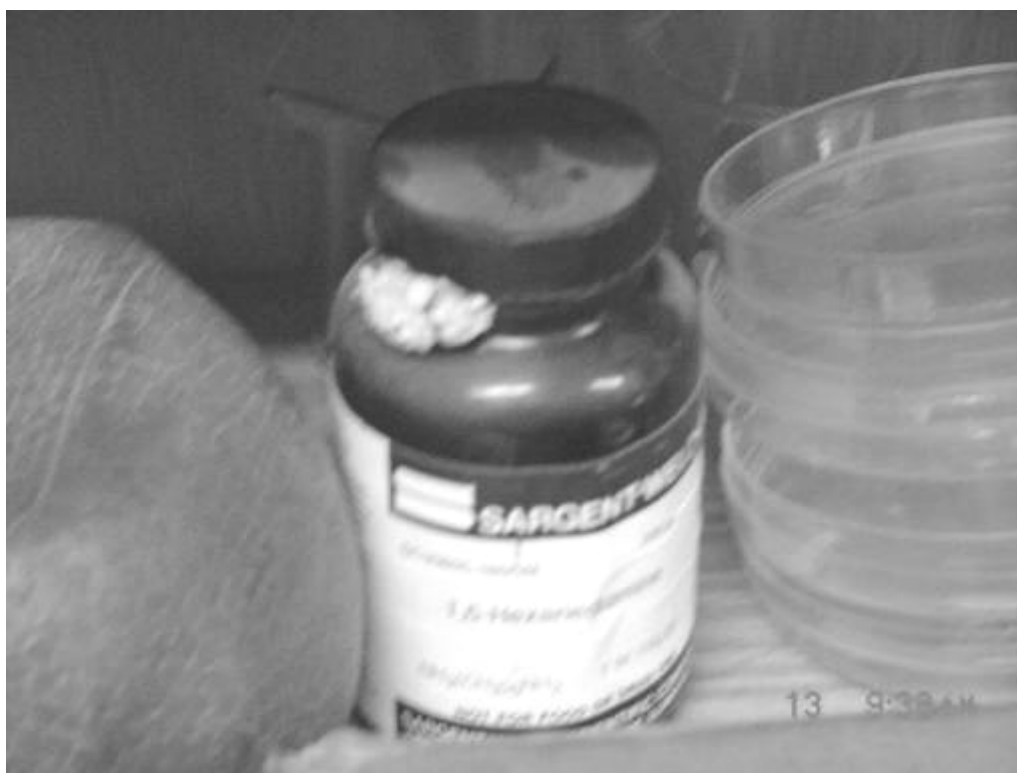
Crystallized Materials on outside of Bottles Indicating Leaking/Off-Gassing of Materials

12. Have a chemical inventory done in all storage areas and classrooms. Properly store flammable materials in a manner consistent with the local fire code. Discard hazardous materials or empty containers of hazardous materials in a manner consistent with environmental statutes and regulations. Label chemical containers with the chemical name of its contents. Follow proper procedures for storing and securing hazardous materials.

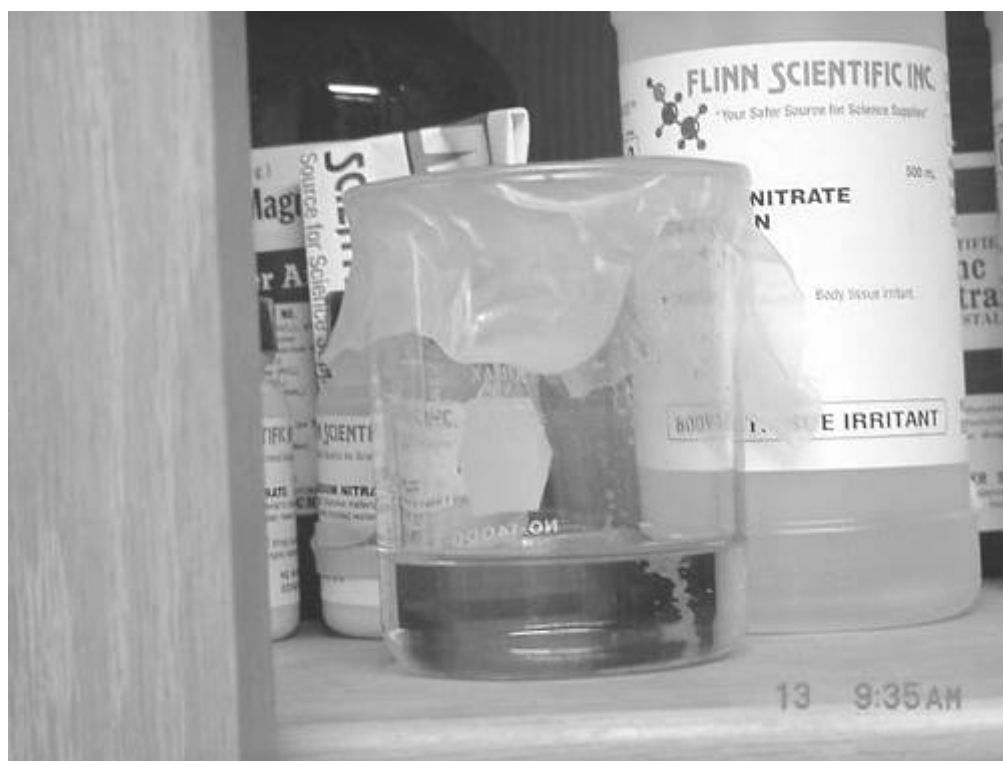
Picture 14

Unlabeled Beaker Sealed With Parafilm

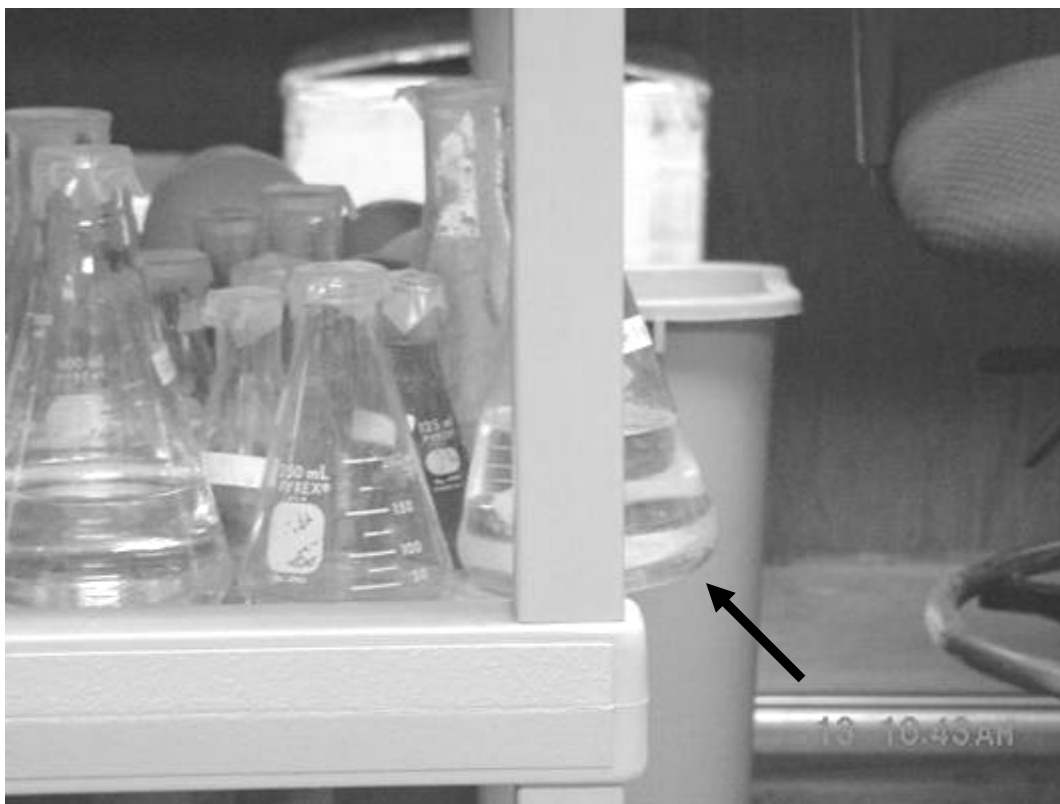
Picture 15

Beakers on Rolling Cart Sealed with Parafilm, Note Beaker Hanging off Edge

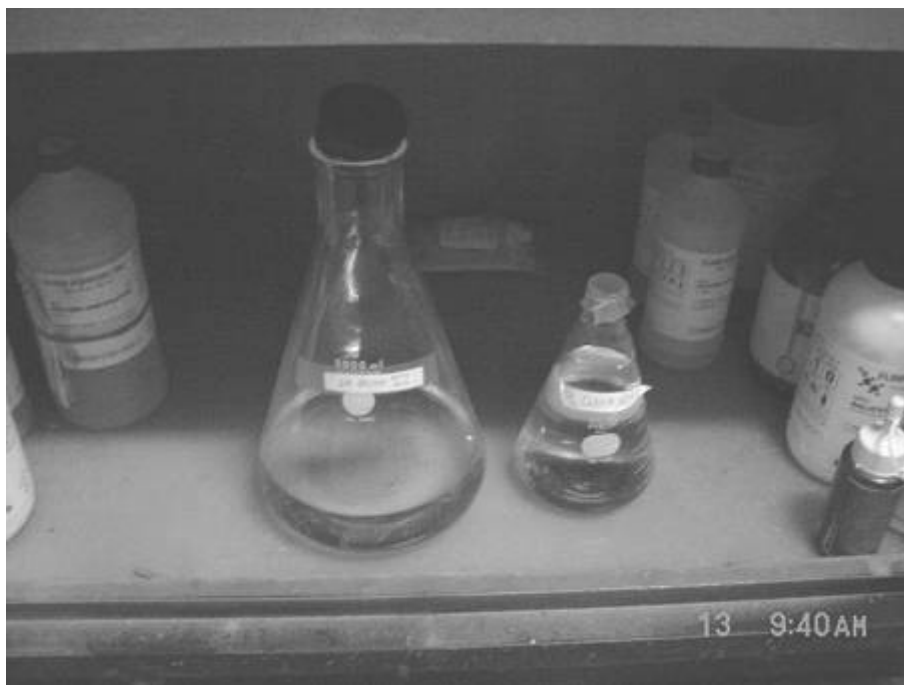
Picture 16

Beakers Sealed with Rubber Stoppers, Note Crystallization on Lip of Beaker on Left Indicating Off-Gassing of Materials

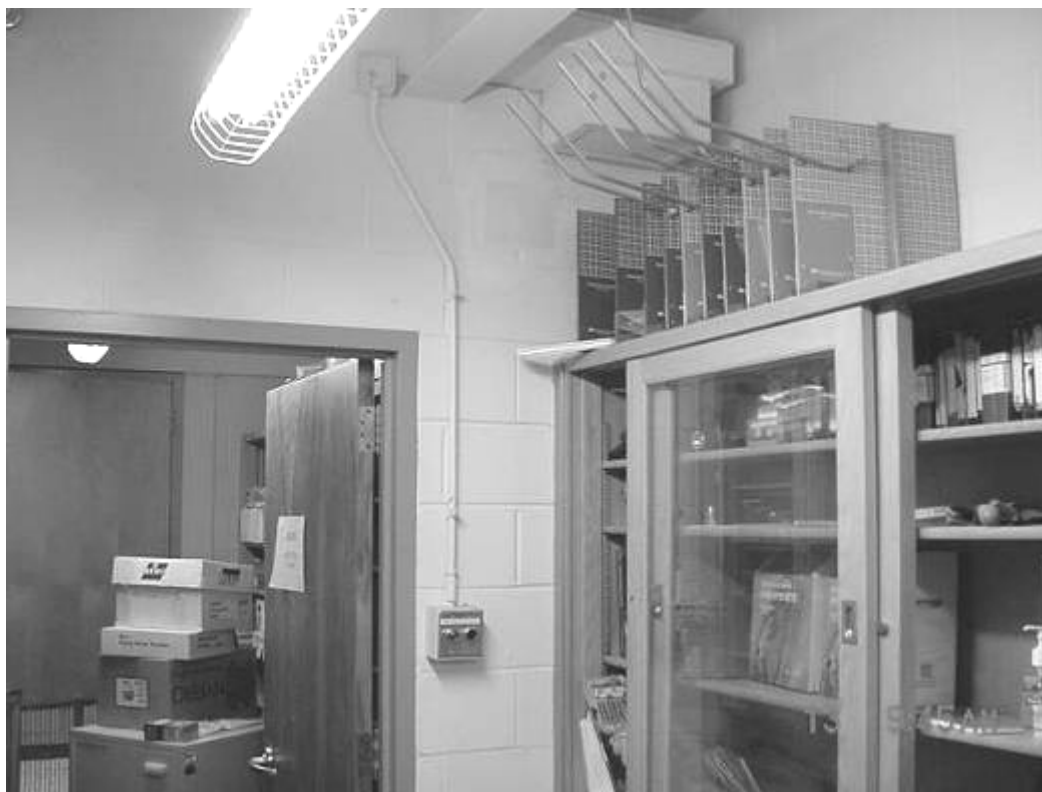
Picture 17

Non-Functioning Local Exhaust Vent and Wall Switch in Prep Room (near 107)

2. Contact an HVAC engineering firm to inspect and ensure local exhaust ventilation for prep rooms is operating as per specifications and develop a preventative maintenance program for this equipment.

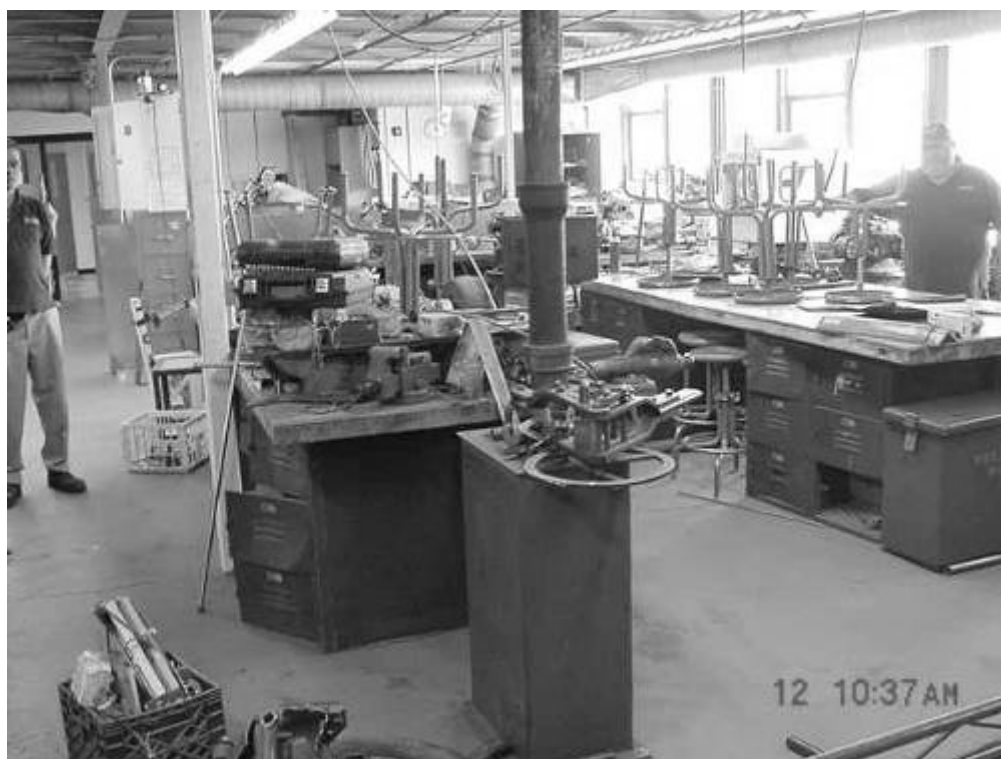
Picture 18

In some classrooms and in the shop areas, items were observed on windowsills, tabletops, counters, bookcases and desks (Picture 18). The large number of items stored in classrooms provides a source for dusts to accumulate. These items (e.g., papers, folders, boxes) make it difficult for custodial staff to clean. Items should be relocated and/or be cleaned periodically to avoid excessive dust build up. In addition, these materials can

Accumulated Items in the Metal Shop

15. Relocate or consider reducing the amount of materials stored in classrooms to allow for more thorough cleaning of classrooms. Clean items regularly with a wet cloth or sponge to prevent excessive dust build-up.

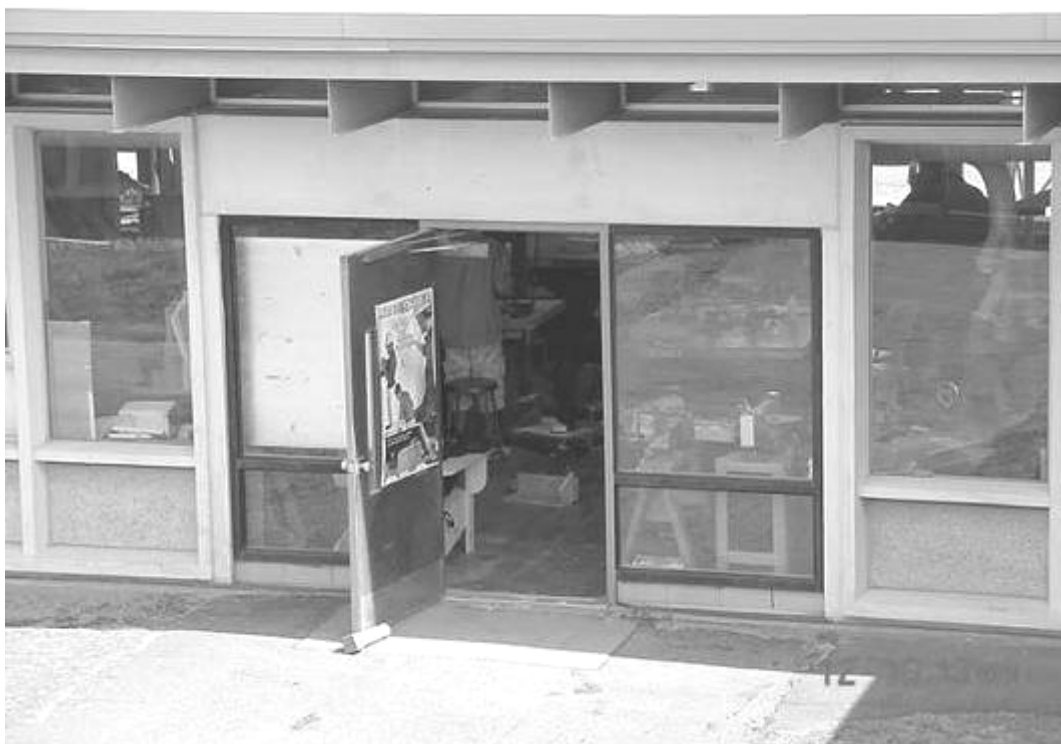
Picture 19

Windows, interior and exterior doors were all found open in the wood shop (Picture 19) during the assessment. The assessment occurred during a breezy day, which *pressurized* the shop forcing odors into the hallway. Once in the hallway odors and particulate matter can migrate to adjacent areas (e.g., the cafeteria) where they can be drawn into the mechanical ventilation system and be distributed to other areas of the building (Picture 20).

Exterior Door to Wood Shop Propped Open

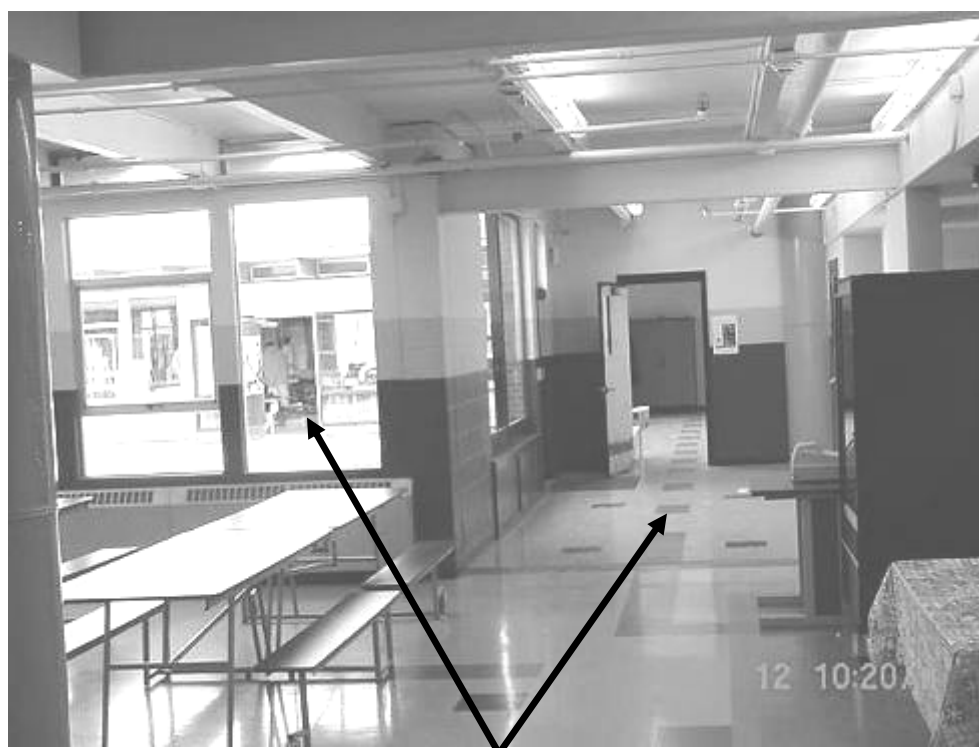
Picture 20

Open Exterior Door to Woodshop and Open Interior Door Connecting Shop Hallway to Cafeteria

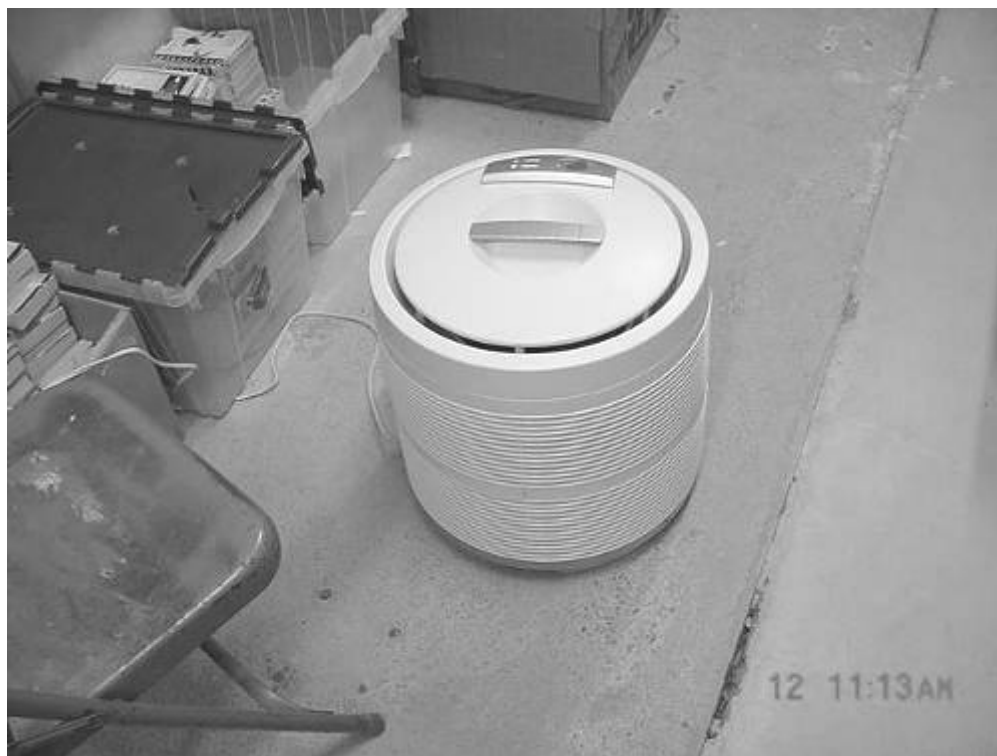
Picture 21

A portable air purifier was in use in storeroom 206-A (Picture 21). This equipment has air filters that should be cleaned or changed as per the manufacturer's instructions to avoid the reaerosolization of dusts and particulates. The filter in the air purifier was examined and found to be saturated with dust and debris. In addition the pre-filter light was "on" (Picture 22) indicating that it needed to be changed.

Portable Air Purifying Unit in Storeroom 206-A

16. Periodically exhaust/return vents of accumulated dust.
17. Clean/change filters for portable air purifiers as per the manufacturer's instructions or more frequently if needed.

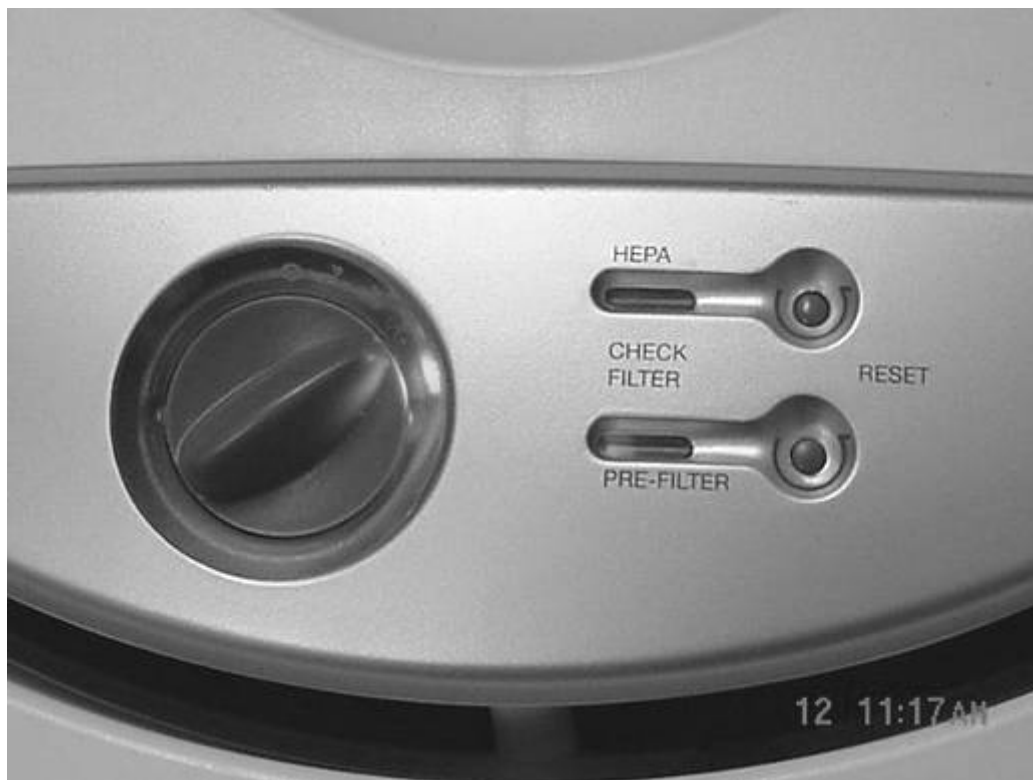
Picture 22

Close-up of Portable Air Purifying Unit in Storeroom 206-A, Indicator lights

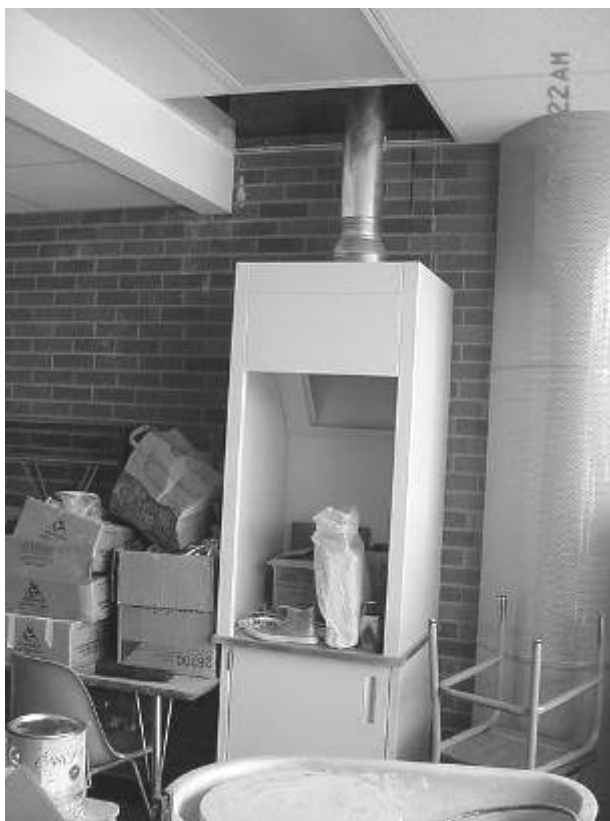
Picture 23

Local Exhaust Hood in Art/Pottery Room

18. To reduce/avoid potential exposure to airborne silica, conduct mixing of clay in local exhaust hood, use wet, pre-mixed clay or clays known to be low in free-silica content. If not feasible, consider discontinuing pottery program. Use wet cutting/cleaning techniques and/or HEPA filtered vacuum cleaners to reduce airborne dust.

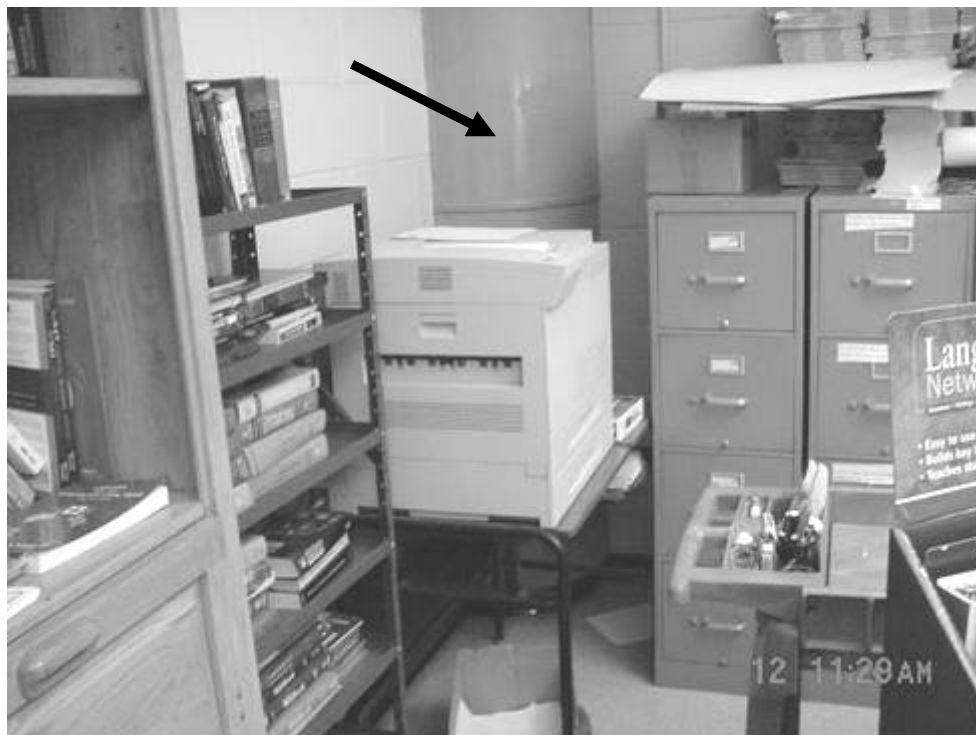
Picture 24

Items Obstructing Airflow from Vent in Vertical Column

3. Remove obstructions from supply vents (Picture 24).
4. Consider having the ventilation system balanced by an HVAC engineer every five years (SMACNA, 1994).
